on the Deconstruction, Relocation and Reinstallation
of MiC units in Nam Cheong 220
Transitional Housing Project

Research Report to the Construction Industry Council, Hong Kong

Project Number: PRMIC2023000049

Jockey Club Design Institute for Social Innovation
& Department of Building & Real Estate
& Chinese National Engineering Research Centre
for Steel Construction (Hong Kong Branch)
The Hong Kong Polytechnic University

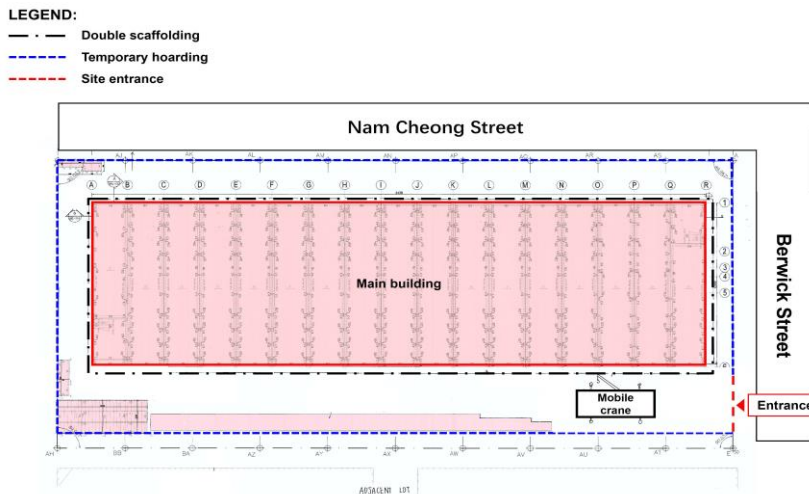
(a). Layout of deconstruction site

(b). Completed hoarding and site entrance

3.2.2 The layout of the construction site is illustrated in [Fig. 8 \(a\)-\(b\)](#). Safety precautionary measures were carried out in strict accordance with the respective applications and statutory approvals granted by the regulatory authorities (completed in January 2023). Temporary hoarding was erected, acting as a physical barrier that separated the construction site from pedestrian and vehicular traffic. This helped limit unauthorized access, thereby preventing potential accidents and ensures the safety of both workers and passerby. A covered walkway and a catch platform were constructed to encircle the site perimeter. Furthermore, a designated site entrance was established to manage the vehicular traffic and prevent unauthorized access.

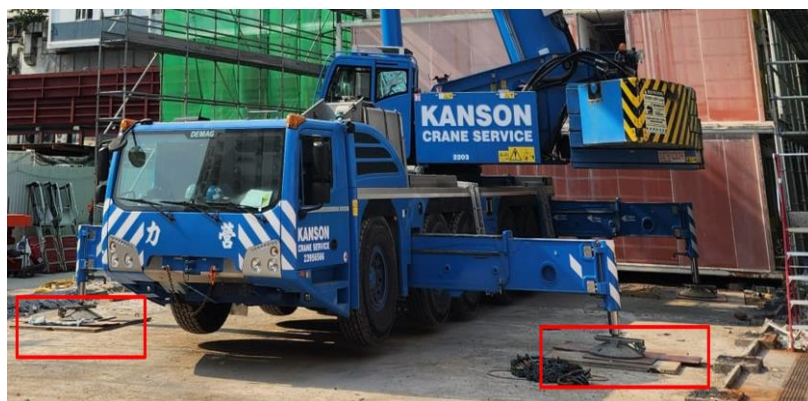
Fig. 9. Placement of timber mats and blocks

3.2.5 Wood timbers or engineered crane pads were positioned beneath the crane's outriggers ([Fig. 9](#)) could provide a stable and level foundation for the mobile crane, minimizing the risk of tilting or overturning due to uneven or unstable ground conditions. Moreover, when the mobile crane lifted a MiC module, heavy loads could be spread over more evenly, thereby maintaining the stability of the crane. This is an essential safety measure of mobile crane operation.

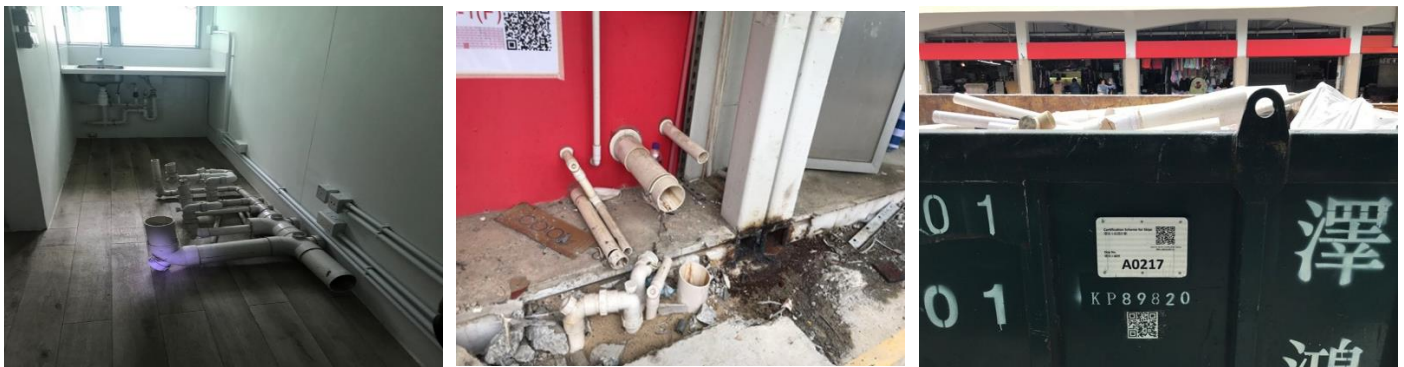
Fig. 9. The main type of waste – external plumbing and drainage pipes

3.2.8 As the removal of external plumbing and drainage pipes did not require statutory approval, it was carried out in advance of the deconstruction works of the modular modules. As illustrated in Fig. 10, all external plumbing and drainage pipes have been cut and loaded to facilitate the dismantling of the MiC module. None of these pipes were reusable and were disposed of at the treatment plant. A new plumbing and drainage system was designed and installed in the next project concerning hygiene issues.

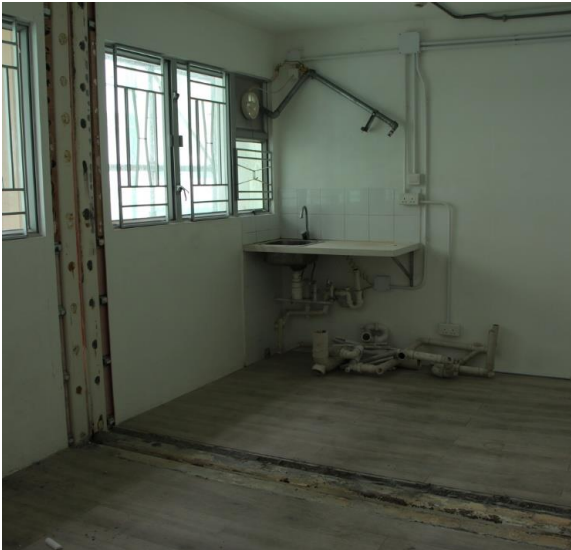
(a). Partial removal of wall finish over joints

Fig. 10. Interior conditions of MiC modules

3.2.9 MiC module's interior conditions (including internal finishes and fixtures) were found to be generally good. Interior finishes over the joint areas (floor and wall covering, ceiling finishes) were partially removed to expose the joint, ready to facilitate joint removal between adjoining modular modules (Fig. 11 (a)-(d)). All interior fittings and equipment were left in their original installed positions during removal, including kitchen sink and cabinets, toilet-shower fittings, fixtures and electric water heaters, window-type air-conditioning modules and metal support frames. Each modular module was assigned a unique quick response (QR) code to aid in identifying the position when it is reinstalled in the future.

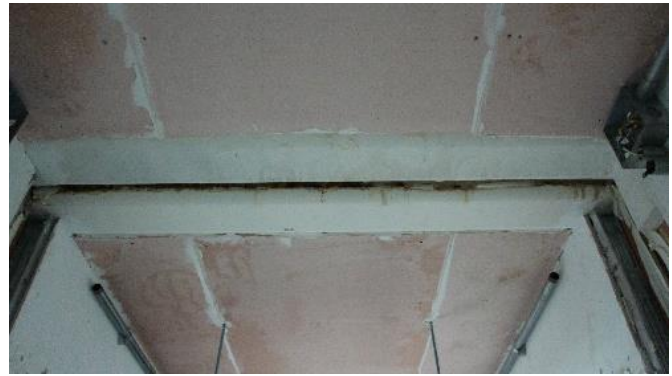
(d). Partial removal of ceiling finishes at joints

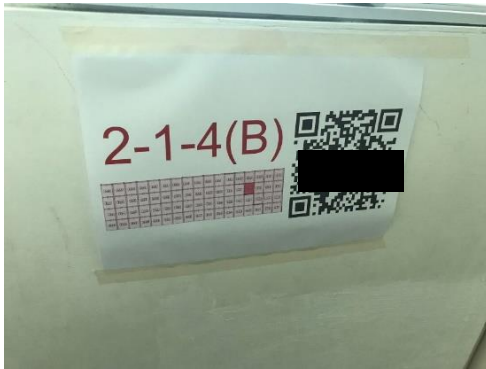
Project Name	Nam Cheong 220 Relocation (under Project : Transitional Housing at Wong Yue Tan, Tai Po)			
Module Code	2-1-2			
Module details	Dimension	Structure	Floor	Function
	(W) (L) (H)	Steel MiC	2/f	Residential Unit
Dismantle Details	Date and time of Dismantle	Name of Supervisor	Serial no of the Mobile Crane	Serial no of the lifting frame
Delivery Detail-01 (from Nam Cheong 220 to reinstatement yard)	Date and time of Delivery	Delivery Truck car plate no	Date and time of arrival	Name of Recipient
Delivery Detail-02 (from reinstatement yard to Wong Yue Tan)	Date and time of Delivery	Delivery Truck car plate no	Date and time of arrival	Name of Recipient
Installation Detail	Date and time of start of Installation	Date and time of completion of Installation		Name of Supervisor
	Serial no of the Mobile Crane	Serial no of the lifting frame

3.2.10 Each MiC module was given a QR code that documents the basic information about the module, such as dimensions, position, and deconstruction and re-installation details (Fig. 12(a)). On-site engineers can quickly obtain module information by scanning QR codes, which assists in locating the MiC module's initial location and facilitating reassembly. Details relevant to the disassembly information, including disassembly time, mobile crane information, and lifting frame information, are also recorded (Fig. 12(b)). Such data assist project personnel in tracking the relocation process and efficiently managing the reuse of MiC modules. Furthermore, delivery and installation details from the reinstatement plant to the new assembly location were electronically recorded. This electronic tracking system was designed to assist practitioners in tracking MiC module information, promoting site management, and improving the efficiency of disassembly and reassembly. This is a good start for the industry to engage with digital practice and to further the change to harvest its benefit.

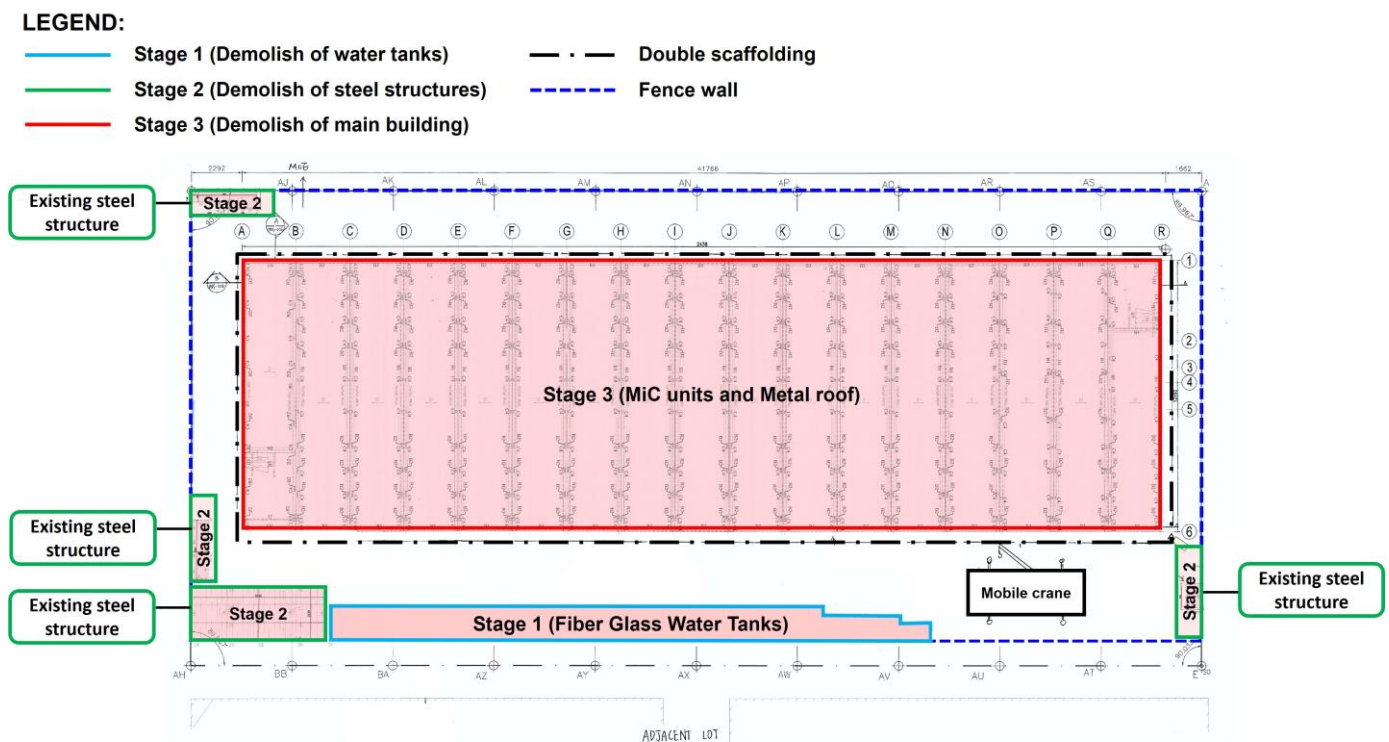
Fig. 12. Master demolition sequence of NC220 project
(Source: Wilson Cheung & Associates)

The deconstruction works were conducted in three stages, as illustrated in [Fig. 13](#). The first stage involved the removal of the existing fiber glass water tanks. In the subsequent stage, the steel structures near the main building were disassembled. The final stage was to remove the metal roof and MiC modules of the main building. The disassembly sequence planning was adopted with a view to ensuring the structural safety and stability of the load-bearing structures.

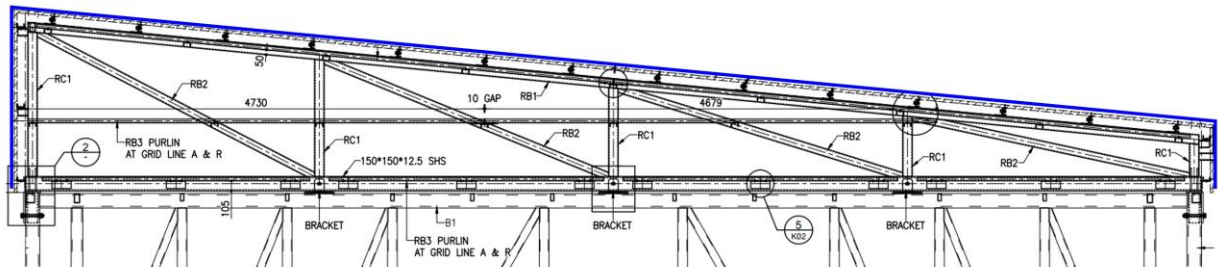
— Roof cover to be removed

(a) Removal of roof cover

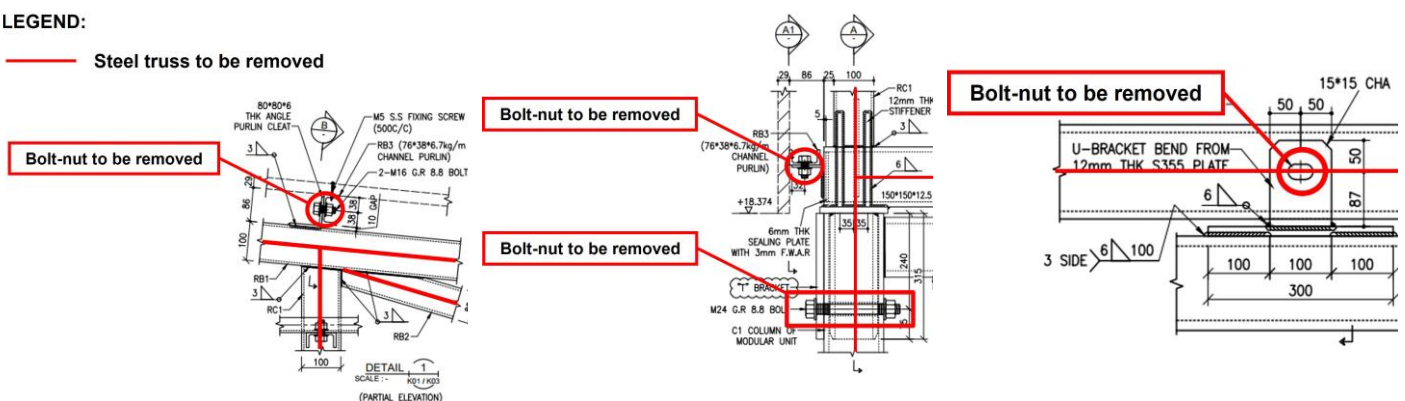
(c) Detail 1

— Steel truss to be removed

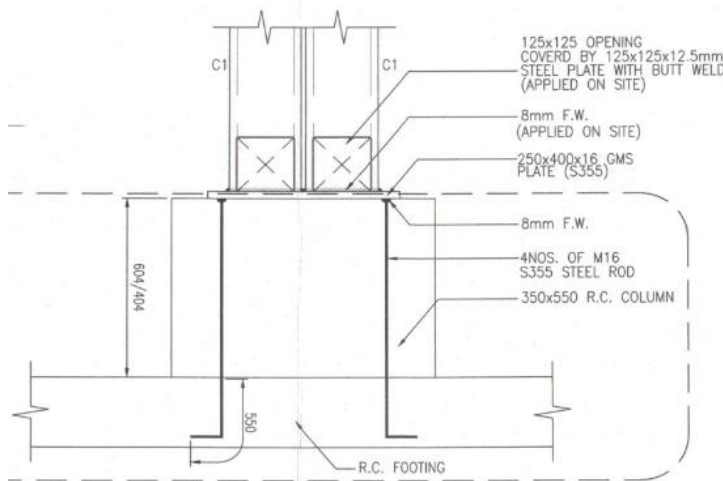
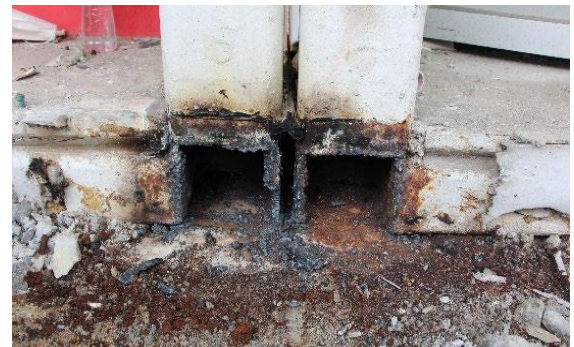
The base plate connection system of the ground-floor MiC modules to the footing is depicted in Fig. 17(a). A base plate was welded to the side column and attached to the concrete footing with four steel rods. The steel rods were cast into the concrete footing and bent to prevent pull-out. According to this design, the side columns of the ground-floor MiC modules were originally welded to base plates. Flame cutting had to be carried out to disconnect the welded connections between side columns from base plates (Fig. 17(b)). Consequently, the affected side columns should be inspected and rectified before reuse. It is therefore recommended that dry connections should be used to improve the ease of disassembly of the ground-floor MiC modules.

(a) Side column originally welded to a base plate

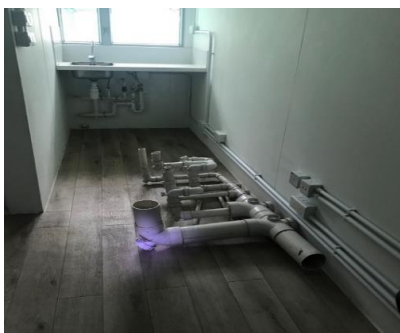
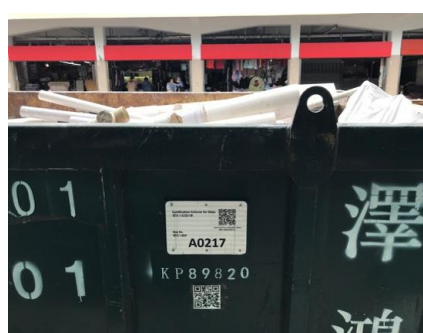
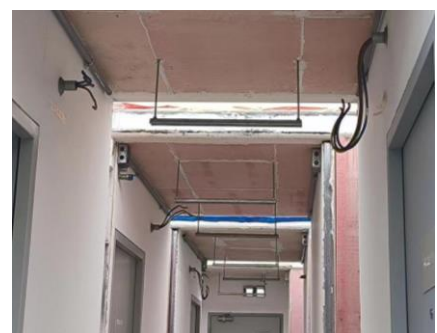
Fig. 18. The main type of wastes: pipes and power cables

We observed that most of the on-site demolition waste included drainpipes on the exterior wall (Fig. 19), which were prior to MiC disassembly. The plumbing system would be redesigned and reinstalled concerning hygiene issues. The electricity cables in the corridors were cut off and would be reinstalled on the new site. The findings indicated that the disassembly of MiC modules induced minimal demolition waste, thereby, significant reusability was achieved.

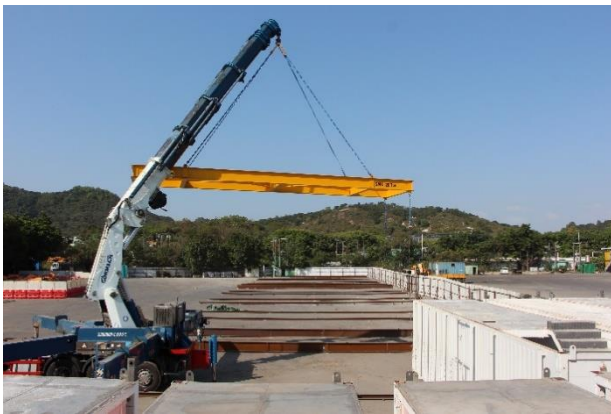
After all MiC modules were transported to the storage yard, they were laid flat for inspection and maintenance to assure the modules' safety and integrity. At the storage yard, a mobile crane was used to lift MiC modules (Fig. 20(a)-(b)) from the trailer to a pre-designated spot. Normally, one crane operator and four coworkers perform lifting activities. The modular modules were placed on leveled steel beams anchored to the ground, which was about 200 mm. The layout of the storage yard followed the sequence of removal (i.e., from zone 1 to 4 in descending order) (Fig. 21). It facilitates future reinstallation when the modules are being transported to the new project site in the reverse order of assembling. The MiC units were placed with protective film covered after touch-ups, which helped reduce further deterioration under extreme weather such as heavy rain in the worst-case scenario.

(a). Placement of MiC modules in sequence

Fig. 19. Placement of MiC modules in the storage yard

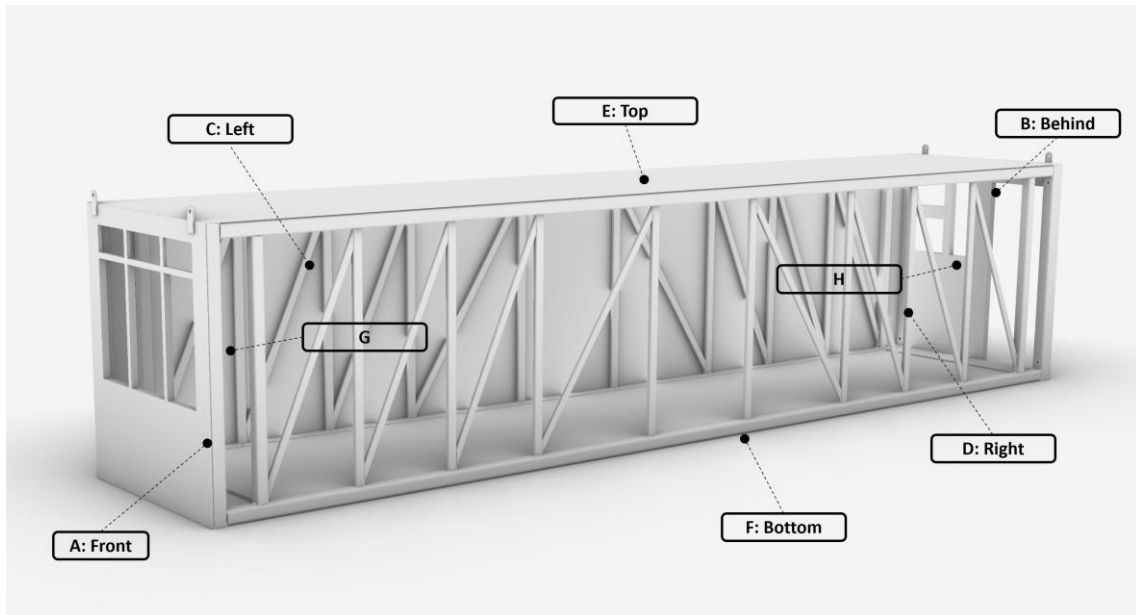
The existing condition surveys should be carried out before and after disassembly of MiC modules, requiring plenty of photo records and documentation. In the near future, it is expected that 29 MiC transitional housing projects (including 10 completed and 19 under construction). Numerous site photos (each module with 8 sides) are expected to be recorded for statutory authorities' inspection, comment, and approval.

Fig. 22. Photo records and documentation taken from 8 sides of each MiC module
A, B, C, D, E, and F sides are the exterior sides, while H and G are the interior sides

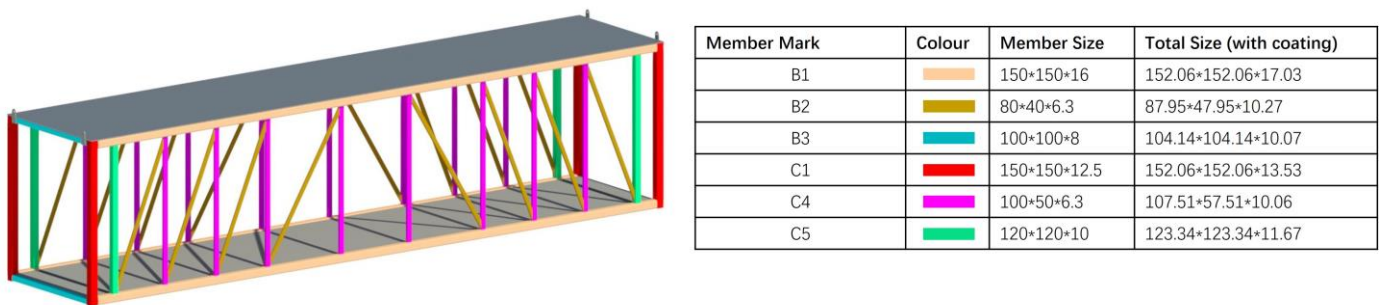
Fig. 24. Steel members mark

As depicted in Fig. 25, the steel frame of the MiC modules is composed of multiple steel members, and the total thickness of each member (including the member thickness and coating thickness) is not consistent. During the measurement process, only the exposed steel members (i.e., B1, C1, C4) were measured, while those members inside the envelope were not measured. The protective coating of the steel members consists of a zinc primer (Thickness: 0.2mm) and fire coating (FM900). The specific thickness of the fire coating and the expected total thickness of each steel members are detailed in Table 6. For detailed comparison of measured size with the approved member size, please refer to Appendix D.

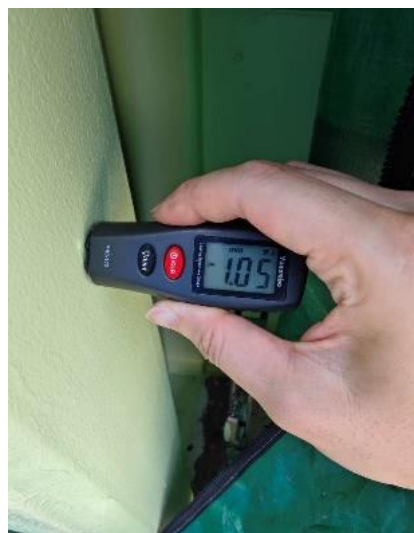
The thickness of the galvanized coating and fire protection paint (firecut FM-900) were measured before reuse, using a calibrated coating thickness gauge with a measurement accuracy of 1 mm. For illustration purposes, the steel member "MiC module 2-2-1, Column C1" was chosen as an example (Fig. 27). It was observed that the measured coating thickness (FM-900 + zin primer = 1.05 mm) of the steel member "Column C1" is larger than the approved thickness (1.032 mm), enhancing fire and anti-corrosion protection. Accordingly, the measured overall dimension of steel section members (Steel section + FM-900 + zin primer = 152.24 mm) is larger than the approved overall size (152.064 mm)(Source: Wilson & Associates).

Fig. 26. Coating thickness of the steel member "Column C1, Location L"
(Source: Wilson & Associates)

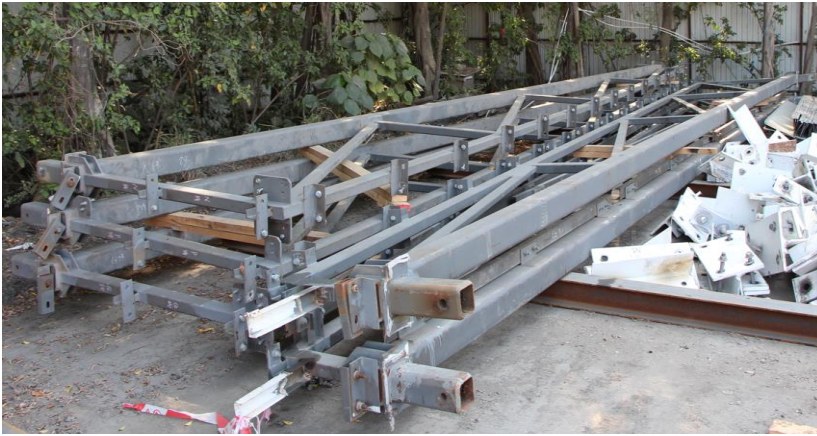
The roofing system in NC220 was also fully relocatable and reusable, consisting of single pitch steel roof trusses, profile aluminum roofing and rainwater gutter (Fig. 29(a)-(c)). They were generally found to be in good condition and reusable for reinstallation.

(a) Steel roof trusses

(b) Detail of roof truss sleeve-bolt connection

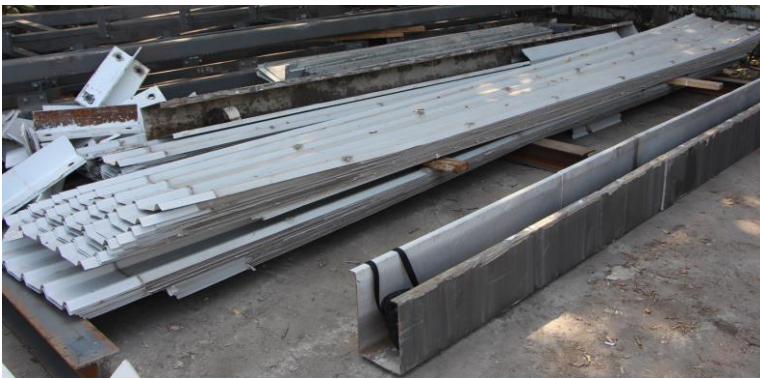
(c) Aluminum roofing and gutter

Fig. 28. Conditions of the roofing system

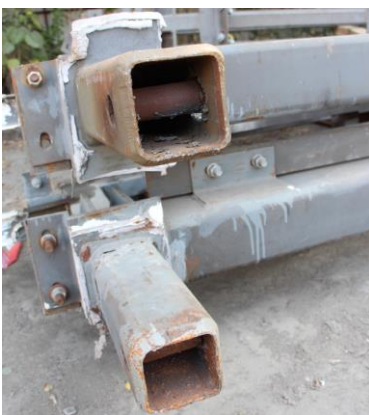
Only a minor touch-up was required to clean rust stains inside a Rectangular Hollow Section (RHS) sleeve at one location of the roof truss connections (Fig. 30(a)). This minor spot rusting indicated that moisture penetration was evident at this particular roof/façade junction. This may be the likely cause of water seepage to the second-floor module below. Despite this, such rust stains would not cause substantial damage to the roofing system. Touch-ups were done through cleaning and coating to enhance corrosion resistance. Fig. 30(b) shows that an on-site worker was using a vernier calliper to measure the thickness of the RHS sleeve to determine its dimensional tolerance.

(a) Rust stains inside an RHS sleeve

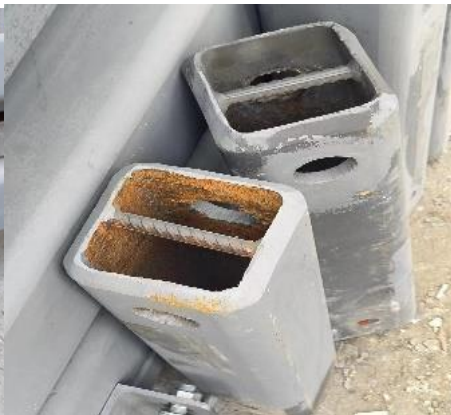
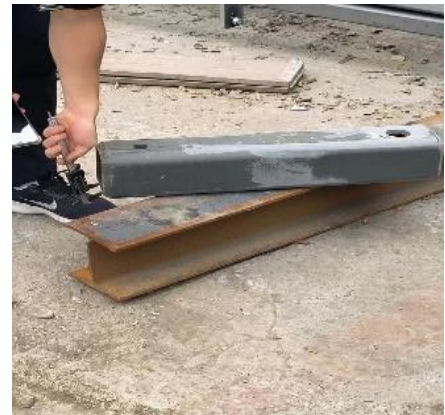
(b) On-site measurement to check dimensional tolerance

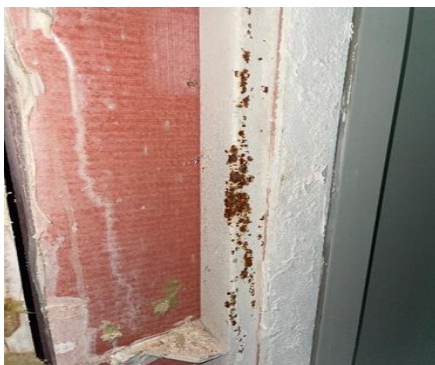
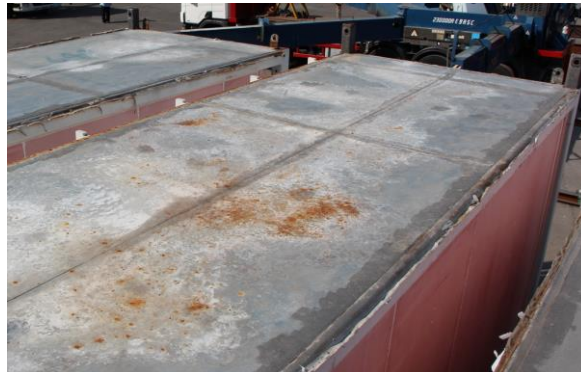
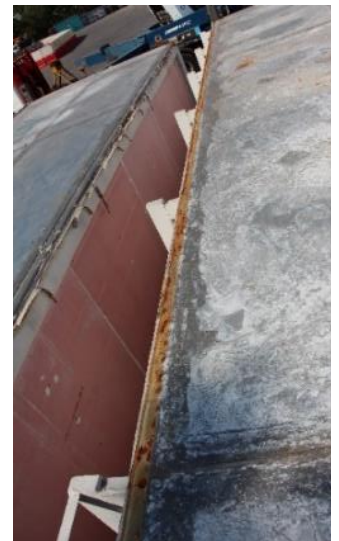
Only minor surface rust stains were found at the vertical inter-module joint of a third-floor module (Fig. 31(a)), and on the top cover panel (Fig. 31(b)) and inter-module joint of one second floor model labeled as 2-1-1 (Fig. 31(c)). This was possibly due to minor rain ingress driven through the gap between the roof and module top, then subsequently seeped downward towards the third-floor and second-floor inter-module joints. The intrusion gap likely corresponded to the small rust stain found inside the RHS sleeve of the roof truss in 4.2.1 above, suggesting moisture penetration at this particular roof-module junction. This observation may likely explain the water leakage found on the corridor floor of the second-floor corridor at the corresponding module location during the tenancy period. These minor surface rust stains have no negative effect on the performance of the building components. Minor touch-ups were required to re-condition the surface. No rust stains were found in other observed modules.

(a) vertical steel frame of a third-floor module

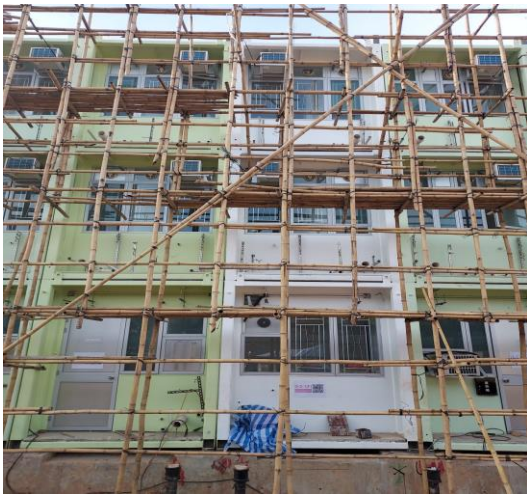
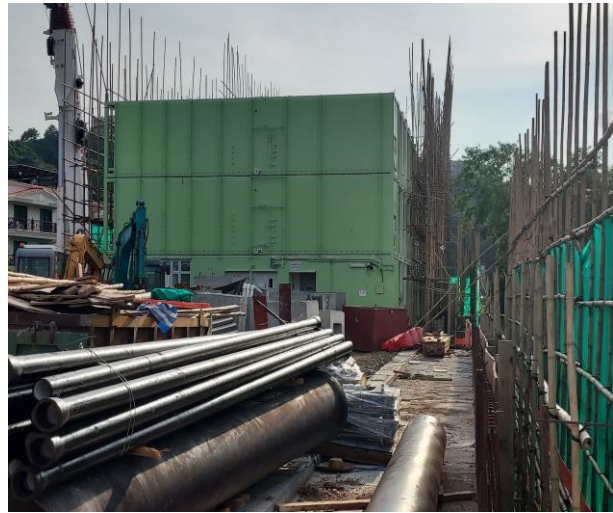
To adapt to the architectural design of the new transitional housing project in Taipo, the exterior of the existing MiC modules was repainted with new colour (Fig. 32(a)-(b)).

(a) Elevation

(b) Left side

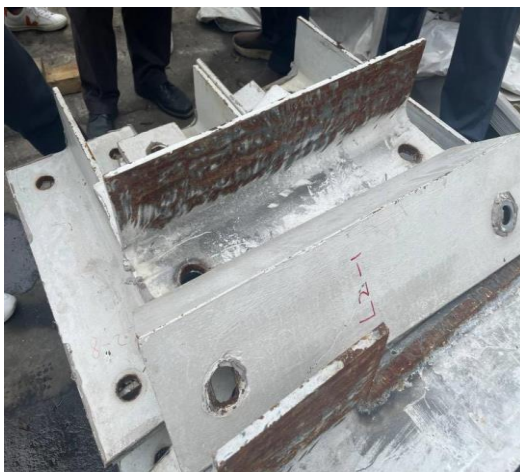
(a) Surface rusting on the back of T-section

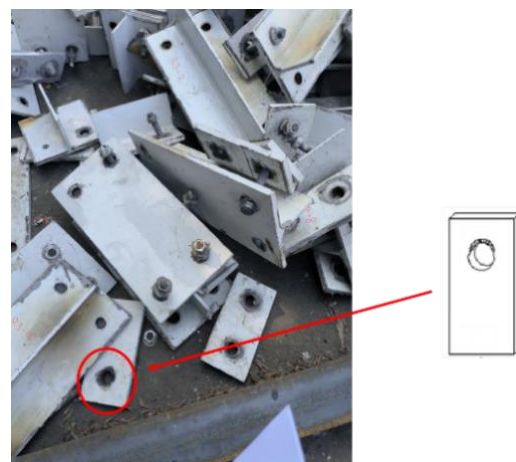
We discovered that a few bolted holes in some of these steel tie plates were slightly elongated due to bearing (Fig. 33(b)). The deformation of these holes was slight and had no main effect on structural integrity. Since almost all connections can be reused in the next project, the bolts, nuts, steel tubes, and tie plates were marked and paired, allowing ease of tracking and reassembly.

(b) Bearing of the steel connection

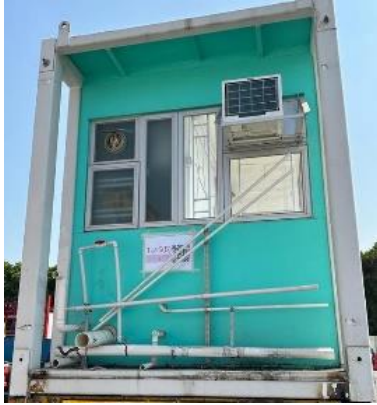
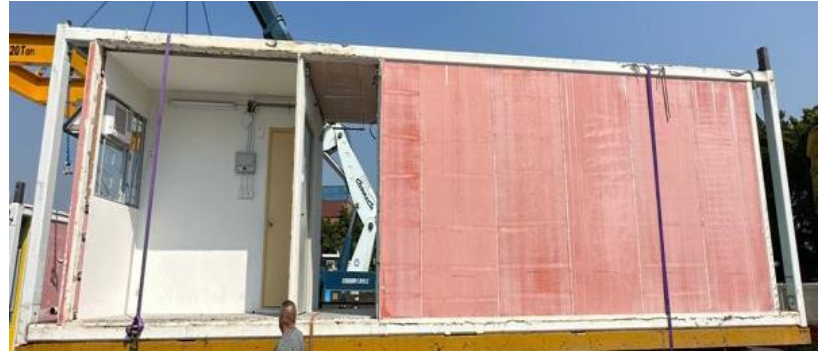
During the site inspection, the steel structural members examined were found to be in good condition, without visible deformation or local buckling observed (Fig. 34(a)-(b)). This is evidenced by the good condition of the pink fire-rated board and fixing crews without the tendency to warp. Minor paint peeling and surface rusting were identified inside beams and columns of the MiC modules “2-1-2,” “2-1-1,” “1-3-2,” “G-2-5,” “3-1-3,” and “3-1-5.” The locations are shown in Fig. 35.

(a) Front side of the typical MiC module

(b) One side of the typical MiC module

Fig. 33. Conditions of exposed steel members

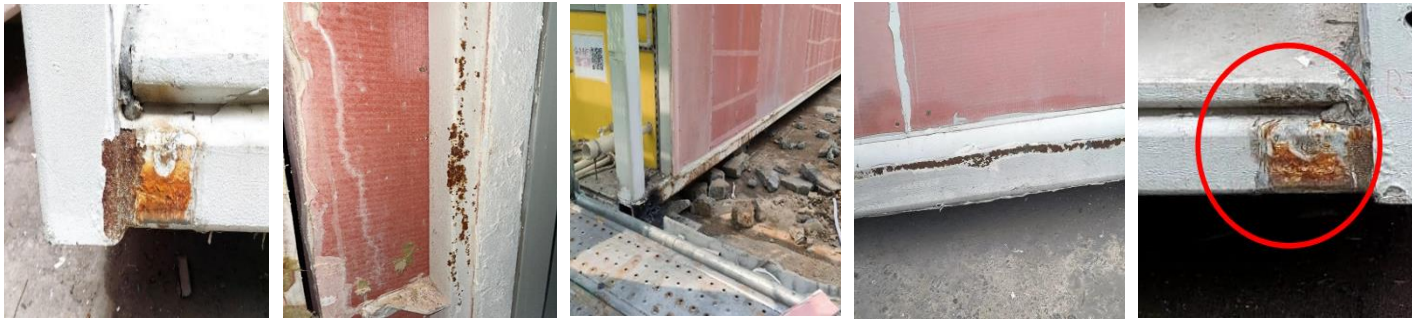
Surface rusts were observed in highly localized areas near the beam-column joints of the modules exposed to weather (Fig. 36(a)). They were believed to be caused by the long-term presence of water in the gaps between the steel beams and the adjacent modules. Besides, surface rusts were identified in a steel member probably because of rainwater seepage (Fig. 36(b)), and in a ground-floor MiC module exposed to ground moisture (Fig. 36(c)). It might be caused by insufficient waterproofing applied to the footing system and steel members. In addition, we also observed that the painting was peeled off from 4 steel members and caused surface rusting. It was possibly caused by the scratch between MiC modules during assembly or disassembly (Fig. 36(d)), or the scratch between the module’s steel member and the lifting eye of the upper or lower adjacent module (Fig. 36(e)). Notably, the very slight surface rusting did not induce significant damage to steel members. Touch-ups were made to remove the rust stains and repaint the affected steel members using corrosion-resistant and fireproofing coating.

(a) Surface rusts near the column-beam junctions

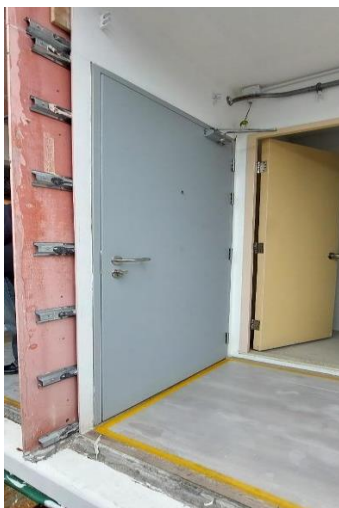
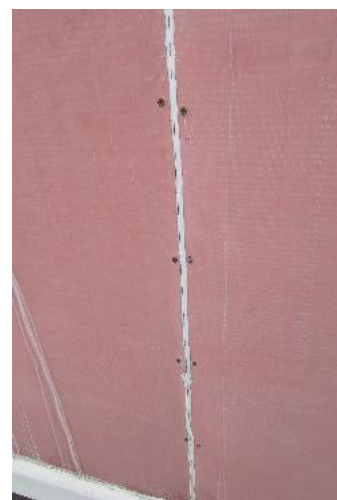
During the site inspection, the fire protection system was found to be in good condition after 2 years of use. The observed fire-rated boards could maintain their positions without signs of distortion (Fig. 37(a)). Almost all the fixing screws of these boards had no sign of tilting or bearing (Fig. 37(b)). Touch-ups were made to replace gemtree boards and fire sealants in the highlighted areas due to normal use (Fig. 37(c)-(e)), whereas fireproof coating was repainted for all steel members to enhance the protection for future use.

(a) Supported fire-rated boards

(b) Fixing screws in good condition

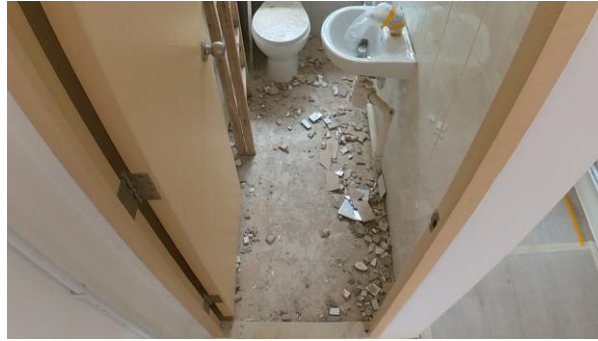
Fig. 37. Tile resurfacing

We observed that the floor, wall and ceiling finishes inside the modules and corridors were generally in good condition. A small quantity of the wall and floor tiles in the toilets showed signs of cracking and peeling due to normal use. These wall and floor tiles were removed and re-laid. (Fig. 38). There was no significant blistering and peeling of paint on the internal walls and ceiling. No mildew growth on the interior surfaces of walls and ceiling was observed, indicating a minimal chance of water seepage inside the MiC module.

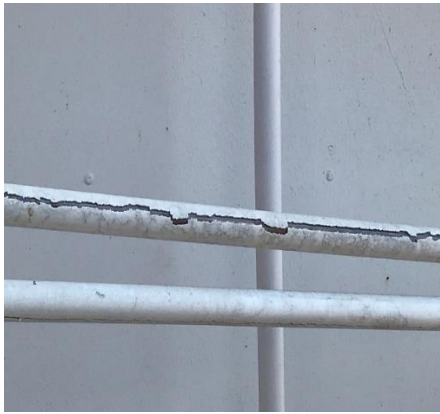
(a) Crack on surface of exposed pipe

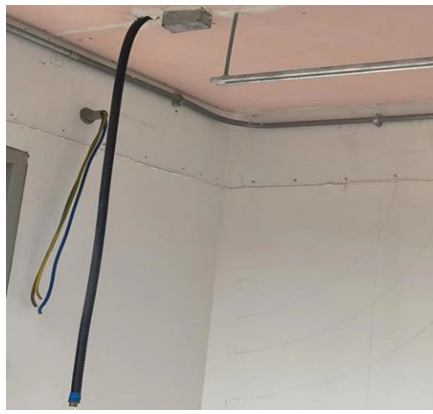
(b) Disconnected wiring

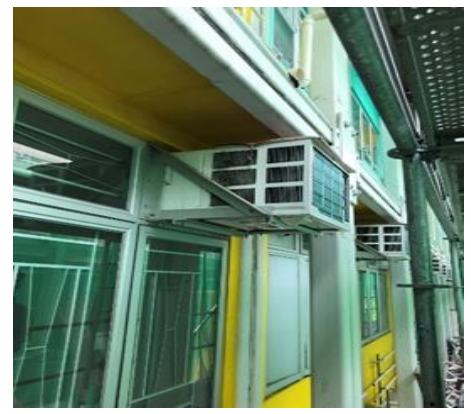
(c) Air-conditioner & support frame

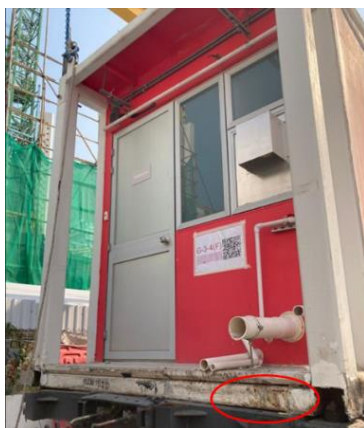
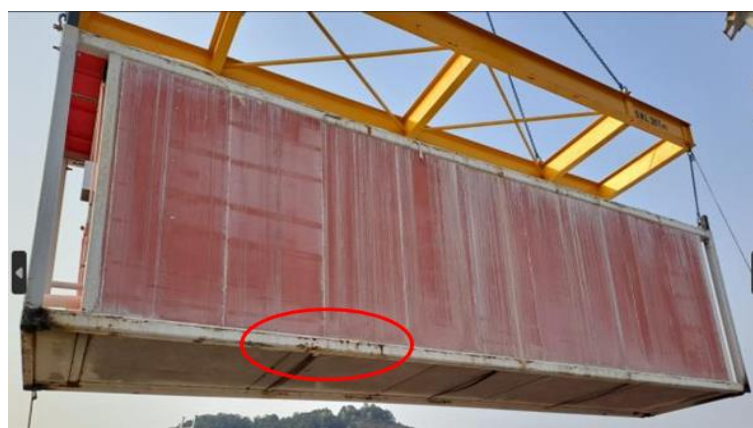
(a) Rust stains on the beam of MiC module G-3-4 (Front side)

(b) Rust stains on the beam of MiC module G-3-4 (Left side)
